MARINE INVESTIGATION REPORT
M99W0133

COLLISION

**BETWEEN THE PLEASURE CRAFT *SUNBOY* AND THE
TUG *JOSE NARVAEZ* TOWING THE
BARGE *TEXADA B.C.*
VANCOUVER HARBOUR, BRITISH COLUMBIA
7 AUGUST 1999**

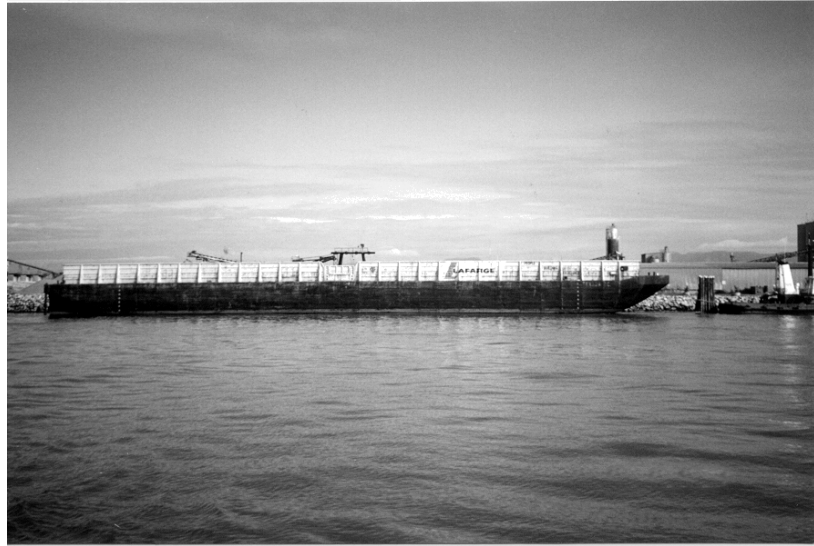
Photo 3
The barge *Texada B.C.*

The barge had three minor abrasions on the port side of the forward rake 1 m below the main deck. Abrasion marks were found approximately 4 m from the towing eyes on the port bridle of the *Texada B.C.* The abrasions were consistent over an area of approximately 4.5 m.

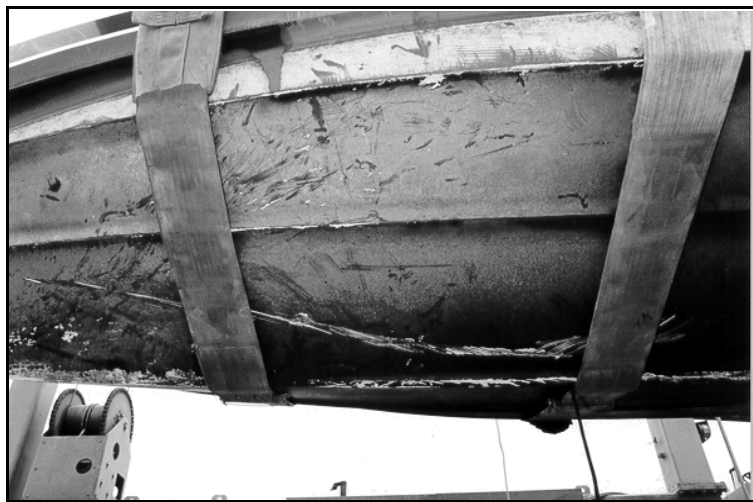
The pleasure craft was extensively damaged, particularly on her port side. The significant structural damage was identified as follows:

- port propeller blades were bent and fractured
- starboard propeller blades were bent, fractured or missing

Photo 4
Damaged hull of the *Sunboy*

- port rudder was bent back and upward sufficient to puncture the hull
- port portion of the underwater hull, keel and chine were heavily scarred
- port lifeline stanchions were torn away from their main deck fittings
- entire bridge superstructure was dislodged and broken in many places
- port salon window was dislodged and missing
- forward window directly ahead of the interior helm was missing.

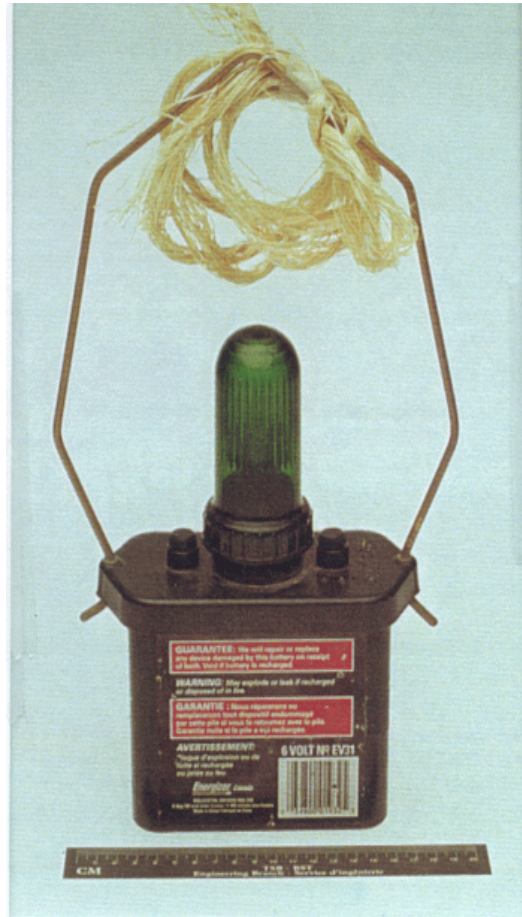
The substitute light in use aboard the *Texada B.C.* on the night of August 7 is commonly referred to as a "Scotty" lantern. It was a 6-volt lantern battery atop which was secured a light assembly with a green lens cap over a clear light bulb. The height of the combined battery and light assembly was approximately 25 cm. Attached to the battery was a wire carrying-handle rising approximately 25 cm above the battery. Tied to the top of the handle of the lantern was a coiled length of twine. The lantern weighed approximately 2.5 kg. Its type is catalogued in the manufacturer's sales material as a barge, boom or portable anchor light designed to be used with a clear lens. It is identified in its packaging as a "Barge and Boom Lantern". (The manufacturer indicated that, with a clear lens, the visibility range is approximately 1 nm.) However, the design permits the clear lenses to be replaced with coloured lenses. The TSB had the lantern tested in an independent laboratory five weeks after the collision, in the presence of representatives of both the owner and the TSB. With a green

Photo 5
The lantern that had been aboard the
Texada B.C.

(starboard) lens, the lantern was found to have a maximum visibility range of less than four cables (0.4 nm). International regulations required the sidelight to have a minimum visibility range of 3 nm. The owners of the tug and barge maintained an inventory of these lanterns and occasionally used them on barges as temporary sidelights.

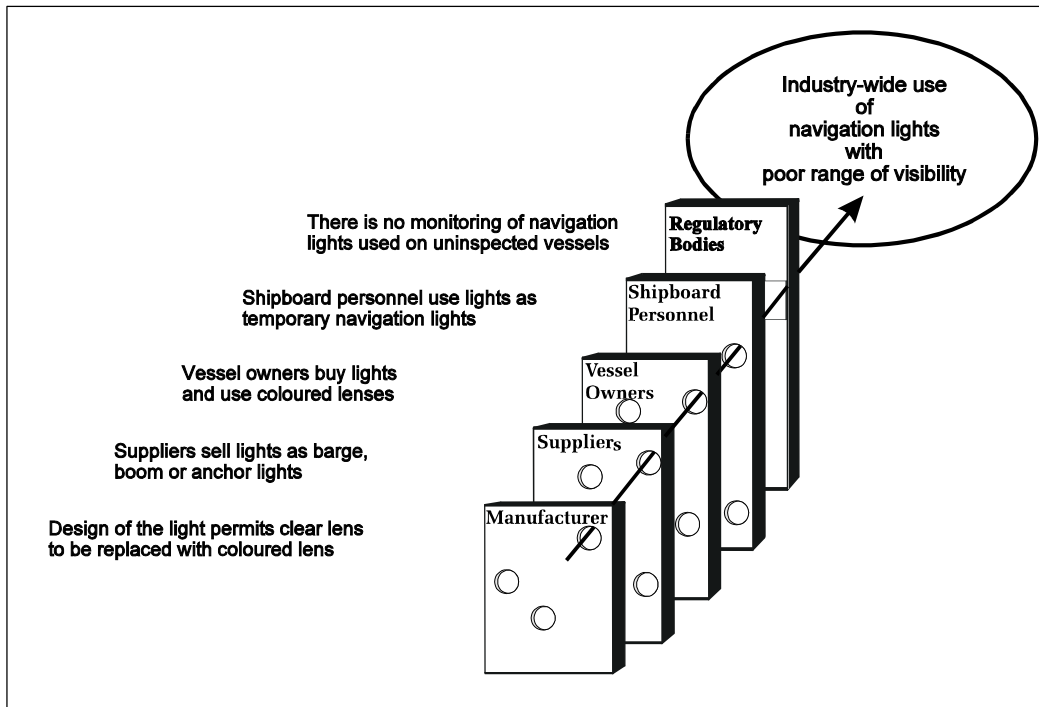
Given the long history of the use of these navigation lights within the industry, and given that these lights are supplied by the company for use as navigation lights, the ship's complement had no reason not to accept them as such. Consequently, the risk associated with the use of these lights was unrecognized and the safety threshold was thus lowered. Reason's model of accident causation is used to illustrate, from a systemic perspective, a number of safety defences that had been breached. The result is the widespread use of lights for navigation purposes that do not meet the safety range of visibility (see Figure 1).

Figure 1
Factors influencing the industry-wide use of lights for navigation with poor range of visibility
(after Reason's model of organizational failure)

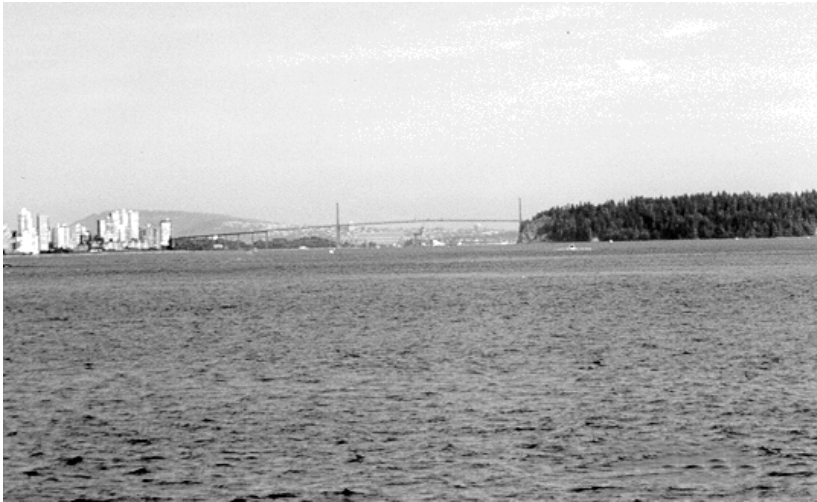
Photo 6

bridge one could see, from left to right, the north shore of Burrard Inlet, buoy “QB”, the unlit area of Stanley Park, a large group of boats assembled around the fireworks barge and, behind them, the shore lights along English Bay beach towards False Creek. As the *Texada B.C.* and the *Sunboy* were on a near-collision course, the bearing of the barge from the *Sunboy* would have remained constant. Hence, the predominately dark barge moving in front of Stanley Park would have been difficult to discern. Given the visibility range of the barge’s starboard sidelight, the sighting of the barge from the *Sunboy* would have been made all the more difficult. This is consistent with the operator’s perception that the barge was an island.

View from the area of the accident looking east. On the right is Stanley Park, which offers a dark background at night.
